CALIFORNIA DIVISION OF MINES AND GEOLOGY  
FAULT EVALUATION REPORT FER-242

FLEXURAL-SLIP FAULTING NEAR PICO CANYON  
Los Angeles County, California

by  
Jerome A. Treiman  
October 3, 1994

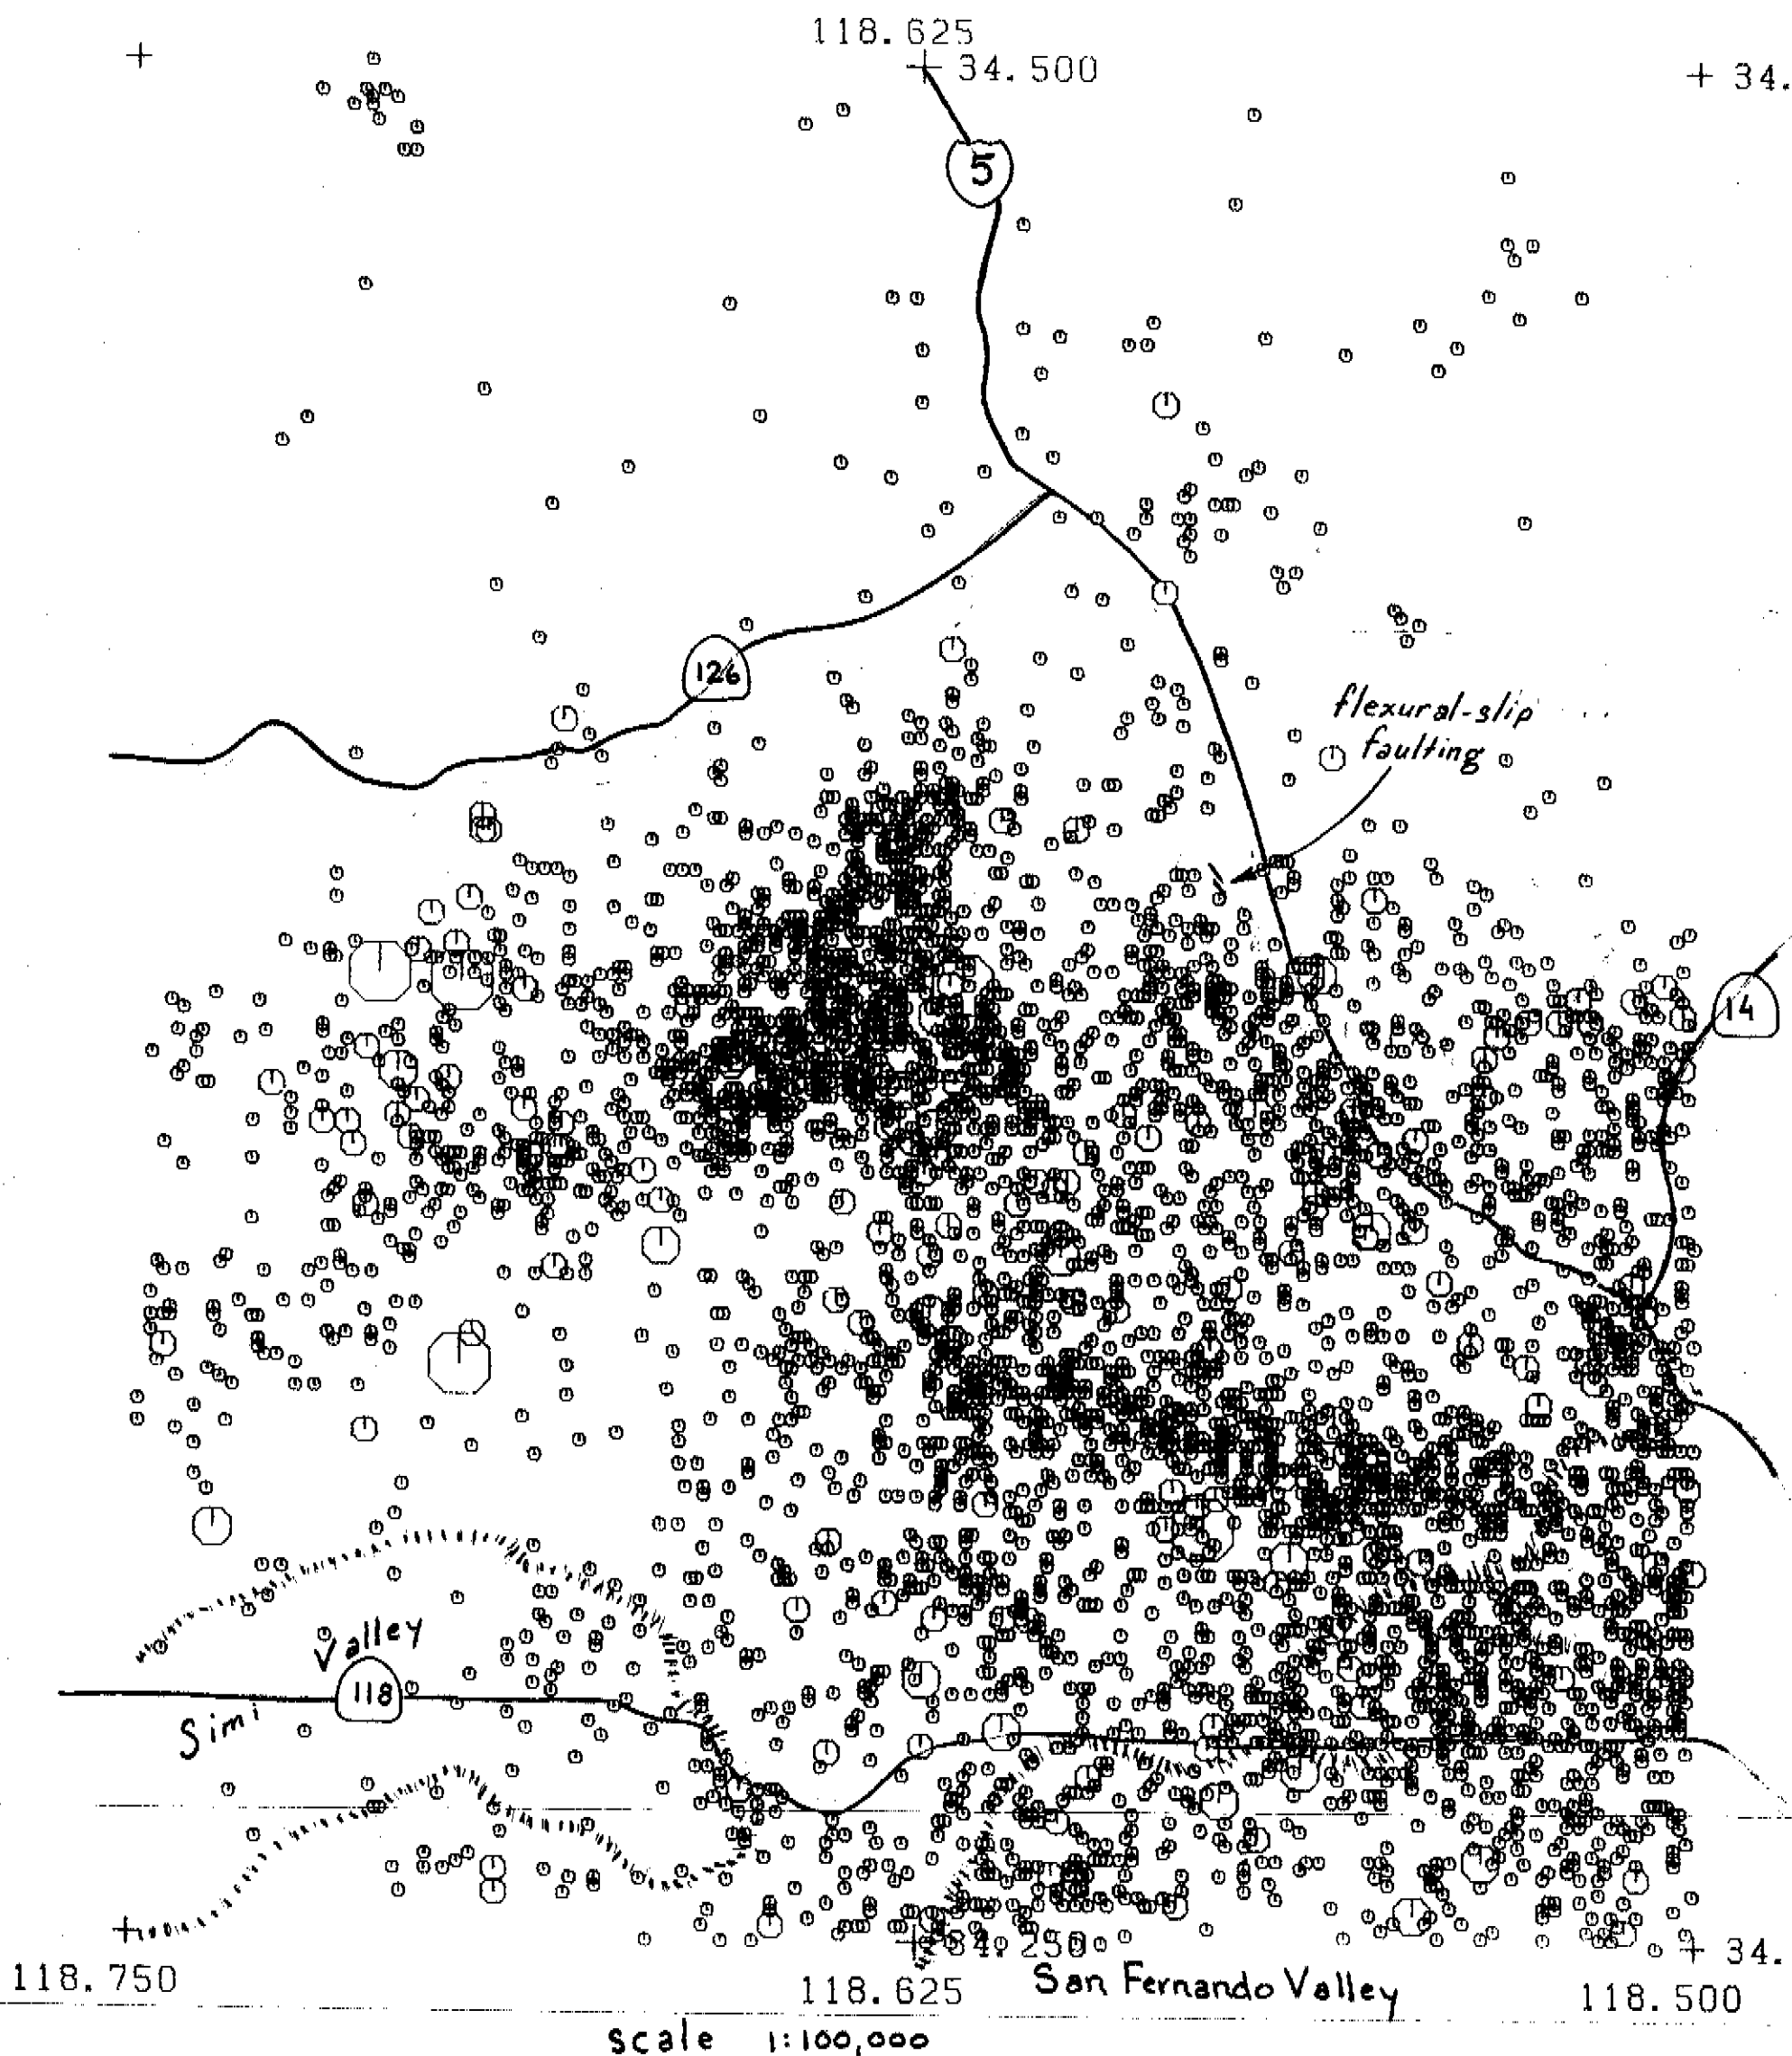
**Figure 4. (FER-242)** Seismicity in the area of Pico Canyon for the period 1/1/94 to 8/20/94; M2.0 and greater.

Seismicity from the Northridge earthquake defines a deep (19km to 6km), south-dipping ( $\approx 40^\circ$ ) fault with scattered shallower aftershocks in the upper block (Hauksson and others, 1994). Figure 4 shows seismicity from 1/1/94 to 8/20/94. Although there is no apparent association of epicenters with the flexural-slip faulting, the rupture area is near the northern margin of an area that is more densely populated with epicenters. This may indicate a relatively abrupt change in the degree of deformation from south to north. It is not expected that significant seismicity will be spatially related to the type of relatively shallow ground rupture that is the subject of this report. Bedding-plane faulting of this nature is secondary to the main seismogenic fault displacement at depth and reflects the regional crustal deformation.
